# Inspection Report

94 Dole Ave  
Crystal Lake IL 60014

## Healthy Home Mold Inspection

## I. INTERIOR SURFACES

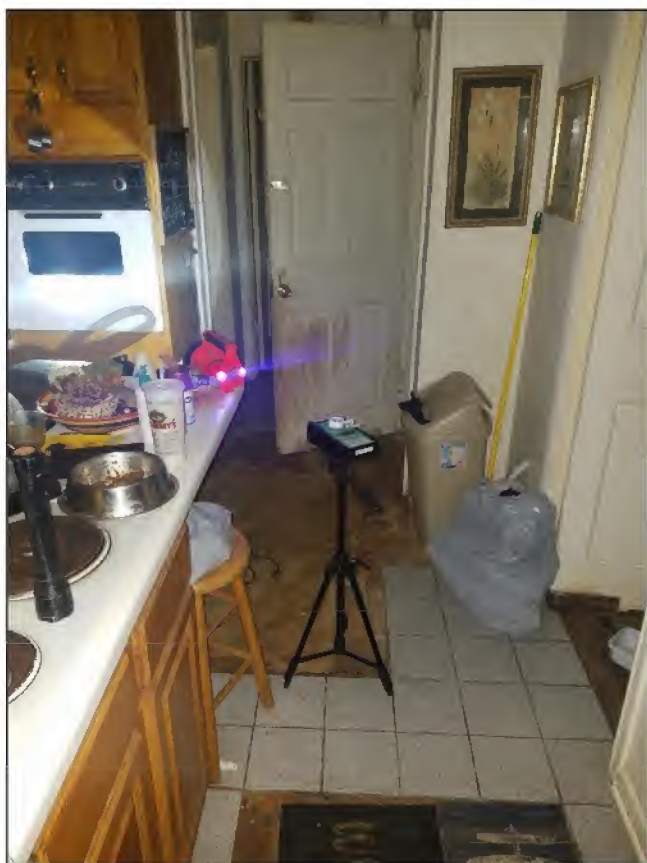
1.0 Item 1(Picture) Kitchen

(1) **Kitchen-** The air quality sample came back with elevated levels of **Penicillium/Aspergillus**.

Humidity levels are high at 62.8 relative humidity. RH levels should stay between 30%-55%

800 spores/m3 or more of **Penicillium/Aspergillus** is considered elevated.

**2230** spores/m3 of **Penicillium/Aspergillus** was detected in kitchen.

Based on mold test results and visual inspection, it is my professional opinion that a qualified remediation company be contracted to perform a mold remediation at the property in question. Anyone entering the property needs to wear masks and not touch moldy materials without wearing gloves.

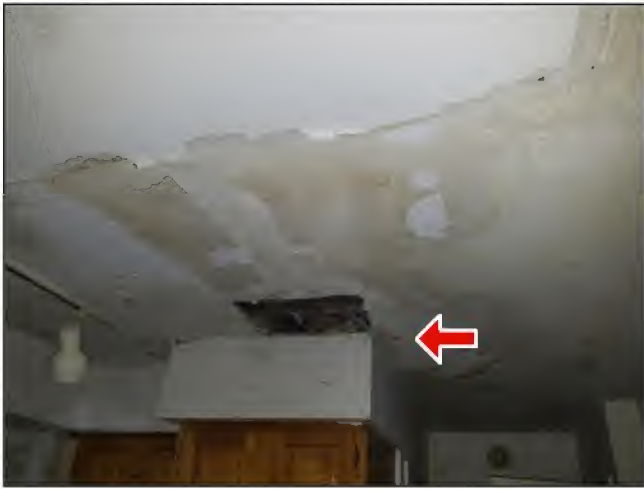
1.0 Item 2(Picture) Kitchen ceiling

(2) Kitchen ceiling has had multiple water intrusions and repairs. Visual mold growth was detected on the drywall.

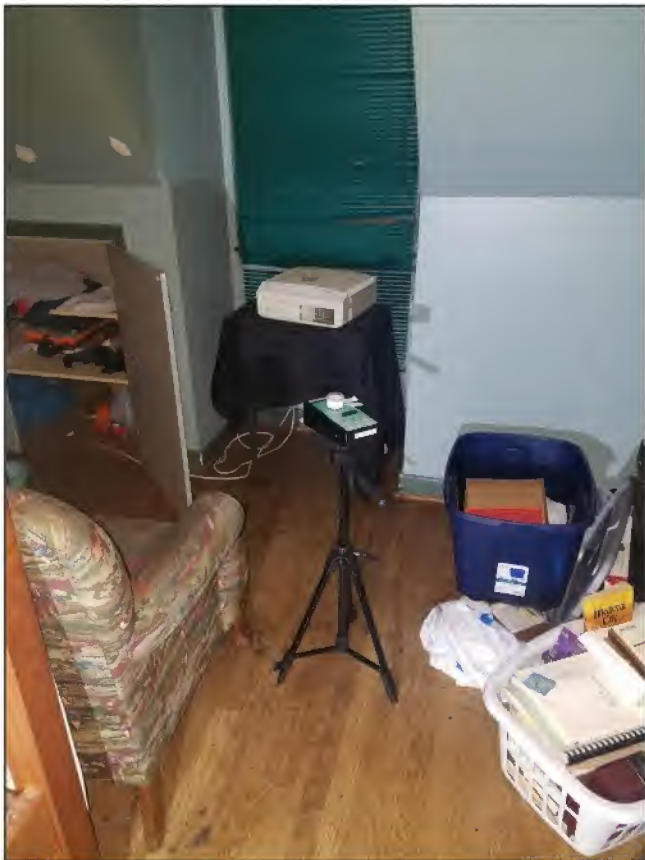
1.1 Item 1(Picture) Master bedroom

(1) **Master bedroom-** The air quality sample came back with elevated levels of **Penicillium/Aspergillus**.

800 spores/m<sup>3</sup> or more of **Penicillium/Aspergillus** is considered elevated.

**1810** spores/m<sup>3</sup> of **Penicillium/Aspergillus** was detected in master bedroom.

Based on mold test results and visual inspection, it is my professional opinion that a qualified remediation company be contracted to perform a mold remediation at the property in question. Anyone entering the property needs to wear masks and not touch moldy materials without wearing gloves.

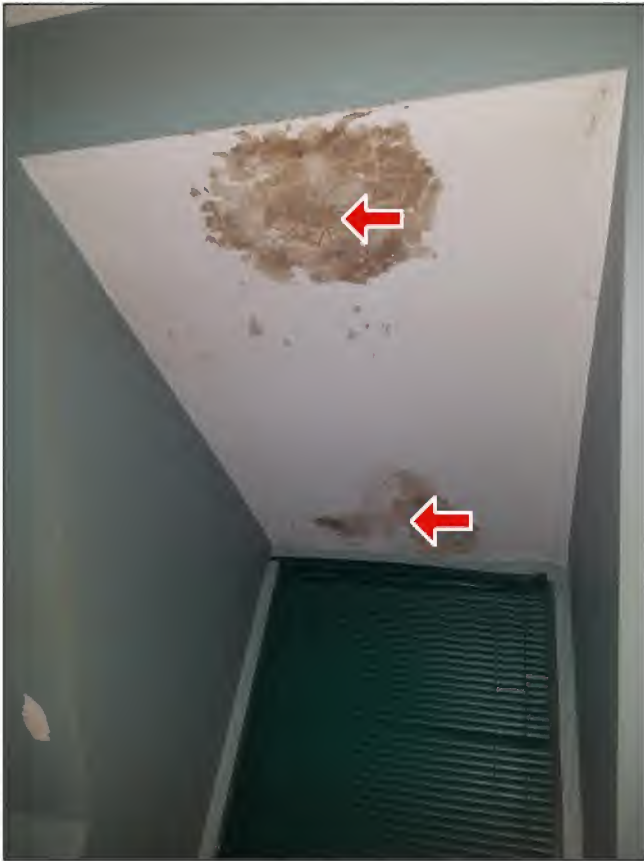
1.1 Item 2(Picture) Master bedroom drywall

(2) Master bedroom drywall- The area in question was tested with a moisture meter resulting high levels of moisture. The drywall is saturated due to a water damage from a leak.

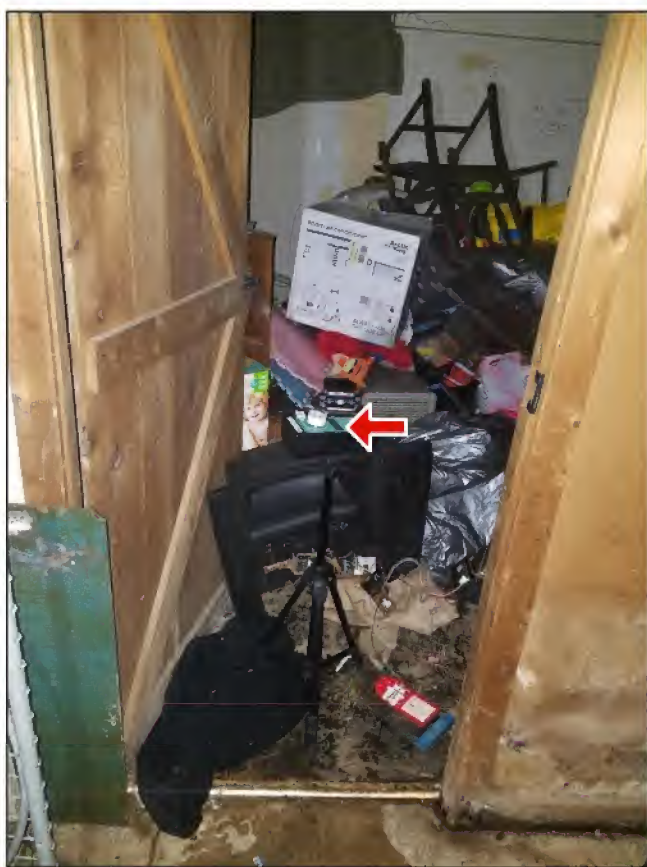
1.2 Item 1(Picture) Basement

(1) **Basement**- The air quality came back with elevated levels of **Penicillium/Aspergillus**, **Stachybotrys (black mold)**, and **Chaetomium**. Humidity levels are high at 75.1 relative humidity. RH levels should stay between 30%-55%

800 spores/m3 or more of **Penicillium/Aspergillus** is considered elevated.

17200 spores/m3 of **Penicillium/Aspergillus** was detected in basement.

5 raw spores or more of **Stachybotrys or Chaetomium** is considered elevated.

57 raw spores of **Chaetomium** was detected in basement.

72 raw spores of **Stachybotrys** was detected in basement.

Based on mold test results and visual inspection, it is my professional opinion that a qualified remediation company be contracted to perform a mold remediation at the property in question. Anyone entering the property needs to wear masks and not touch moldy materials without wearing gloves.

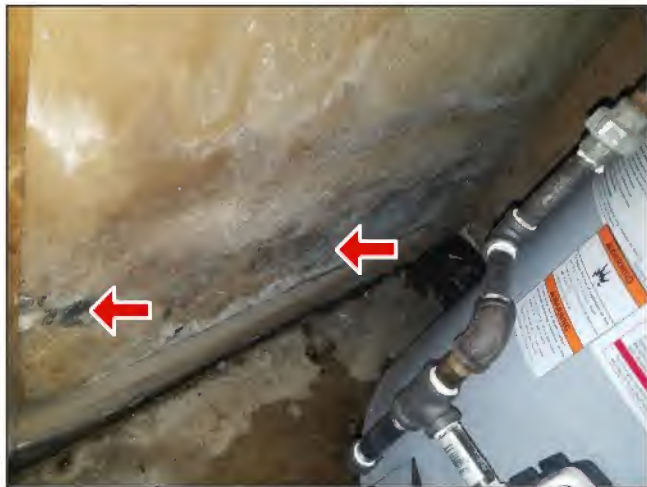
1.2 Item 2(Picture) Basement drywall

(2) **Basement drywall-** The surface sample came back with elevated levels of **Penicillium/Aspergillus & Stachybotrys**.

Standing water was detected in the basement. Multiple areas of visual mold growth was detected on items throughout the basement. Visual growth was also detected on the basement ceiling joists.

Based on mold test results and visual inspection, it is my professional opinion that a qualified remediation company be contracted to perform a mold remediation at the property in question
